# Manhole Inspection Summary

Manhole # S25QQ1001MH

**Location** Address: **12 CLUB RD**

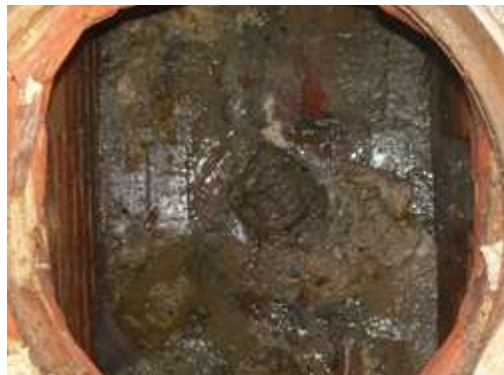
Top View

Channel debris.

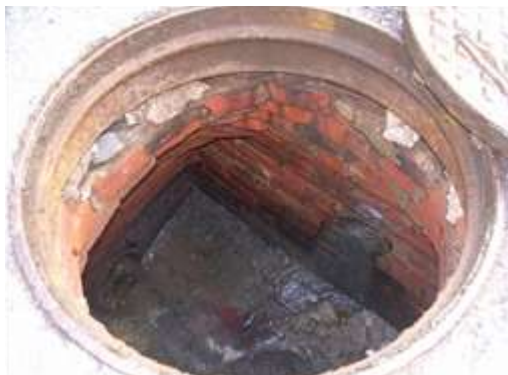
Defect

Frame leaks. Adjustment deterioration, loose brick and infiltration. Corbel and Barrel infiltration - other side.

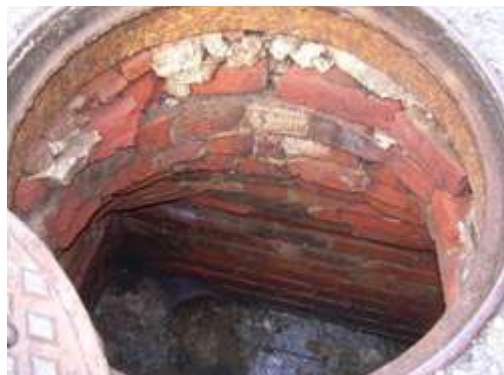
Defect

Adjustment deterioration, loose brick and infiltration. Corbel and Barrel infiltration.

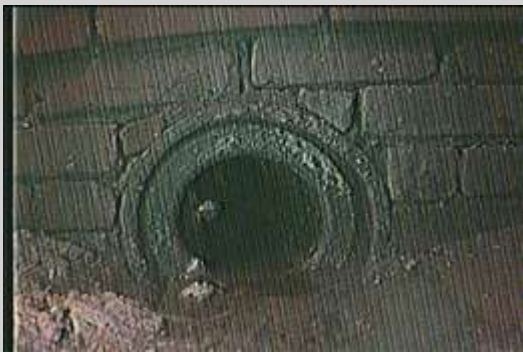
### 6 in. Circular Gravity Sewer Pipe Out @ 12 O'Clock

Barrel deterioration and infiltration..

Infiltration: **Evidence** Pipe Seal Cond: **Cracked**

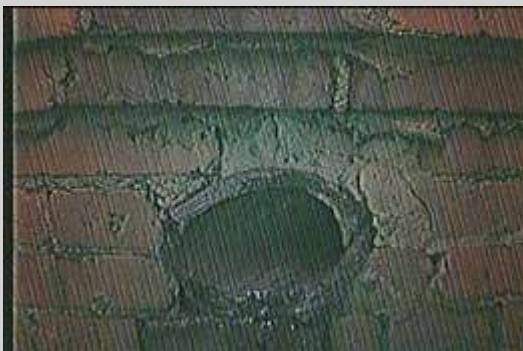
### 4 in. Circular Gravity Sewer Pipe In @ 3 O'Clock

Infiltration: **Evidence** Pipe Seal Cond: **Cracked**

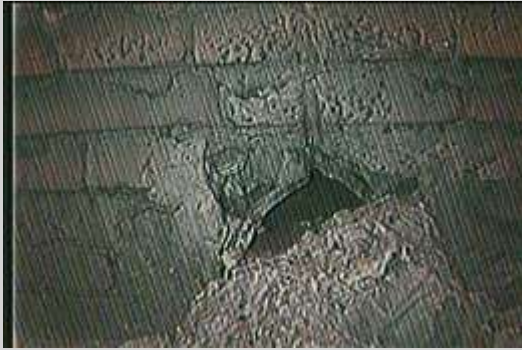
Pipe In @ 6 O'Clock

Deposits: ☐ None ☐ Mud ☐ Sludge ☒ **Debris** ☐ Grease

Silt Depth: **4** (in.) Deposits Extent: **Heavy**

Infiltration: **None** Pipe Seal Cond: **Broken**

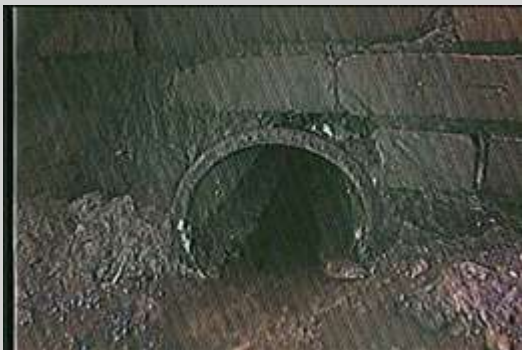
Pipe In @ 7 O'Clock

Infiltration: **Evidence** Pipe Seal Cond: **Cracked**
